**REPORT NO. TS769 Revision A**

# Simulated Wind Driven Debris Impact Testing of Longspan Roof Cladding

Cyclone Testing Station  
School of Engineering and Physical Sciences  
James Cook University

for Queensland Government  
Department of Public Works  
GPO Box 2457, Brisbane, QLD 4001

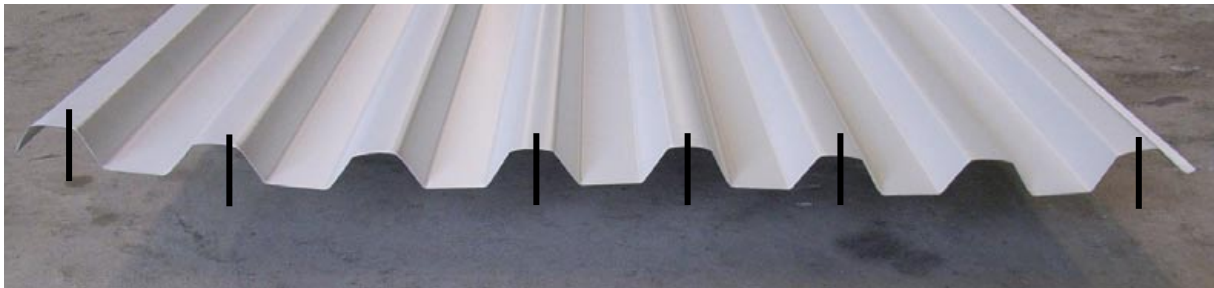
**Figure 1:** End view of Longspan cladding showing fixing pattern

The test roof specimens were set up in a 900 mm triple span arrangement, supported by 1.5 mm BMT steel z-purlins (Z151015). The cladding was screw fixed to the support as per manufacturer's installation manual using 14-10 x 50 mm self-drilling metal screws fitted with *Square-Lok* cyclone washers.

The Longspan steel cladding used in this test program was rolled from G550 steel sheeting with a stated Base Metal Thickness (BMT) of 0.48 mm. The total sheet width is approximately 750 mm with eight ribs per sheet which are spaced at 100 mm centres. The cover width of the cladding is 700 mm and the ribs are approximately 27 mm high, 25 mm wide at the top and 60 mm wide at the bottom; the width of the pans between the ribs is 40 mm. Figure 1 presents an end view that shows the sheeting profile. The cladding has an anti-capillary side-lap, visible as an extension on the far right rib in Figure 1.

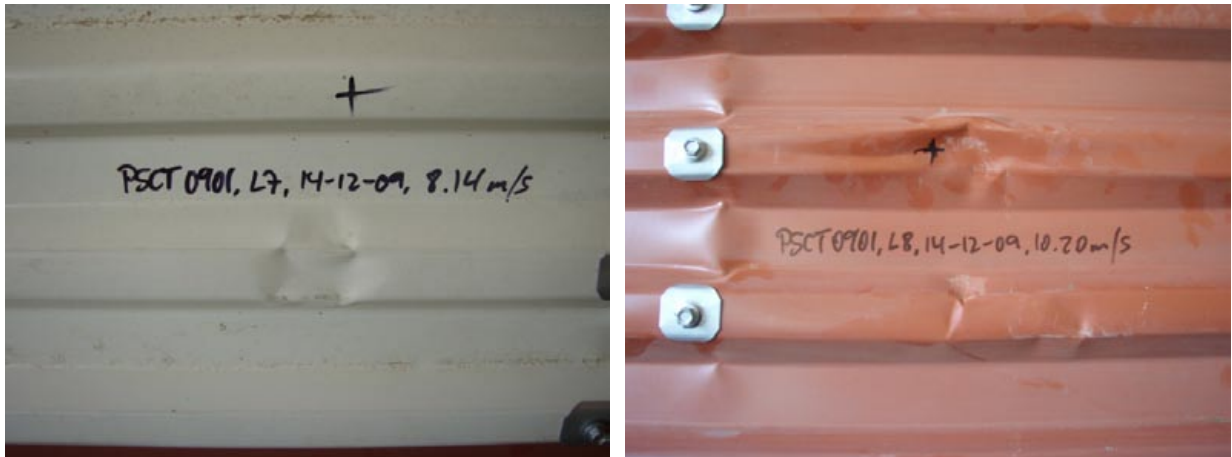
**Figure 5:** Cladding damage after Trials L7 (left) and L8 (right)

| Trial No. | Date tested | Impact Location | Impact Velocity (m/s) | Results and Observations |
|---|---|---|---|---|
| L7 | 14 Dec 2009 | Centre of sheet, next to internal support in end span | 8.1 | Pass. Deformation across 1 rib. |
| L8 | 14 Dec 2009 | Centre of sheet, next to internal support in internal span | 9.8 | Pass. Deformation across 2 ribs. |
