REPORT NO. TS775

Simulated Wind Driven Debris Impact Testing of External Personal Access Doors

Cyclone Testing Station
School of Engineering and Physical Sciences
James Cook University

for Queensland Government
Department of Public Works
GPO Box 2457, Brisbane, QLD 4001

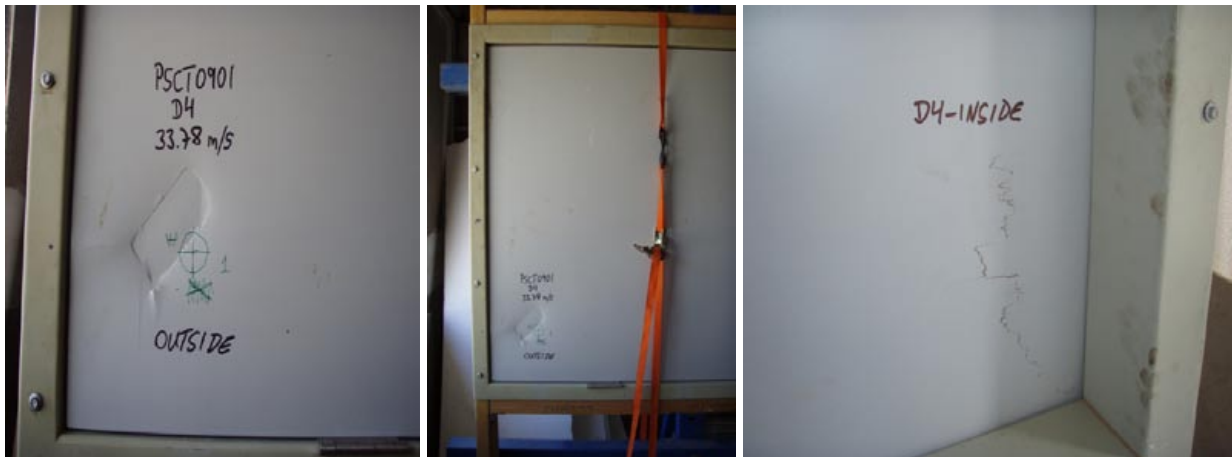
Figure 1: Door damage after Trial SS1

Trial No.	Date Tested	Impact Location	Impact Velocity (m/s)	Results and Observations
SS1	25 Nov 2009	Top corner, hinged edge	33.8	Pass. Indentation in door. Interior ply face fractured slightly.
SS2	25 Nov 2009	Mid height, hinged edge	34.7	Pass. Indentation in door. Interior ply face fractured slightly.
SS3	26 Nov 2009	Centre, next to bottom edge	35.7	Pass. Indentation in door. Interior ply face fractured slightly.
SU1	19 Jan 2010	Top corner, hinged edge	36.2	Pass. Door deformed along internal SHS frame.
SU2	19 Jan 2010	Centre, next to bottom edge	33.3	Pass. Door deformed along internal SHS frame.
SU3	19 Jan 2010	Mid height, hinged edge	36.8	Pass. Door deformed along internal SHS frame.

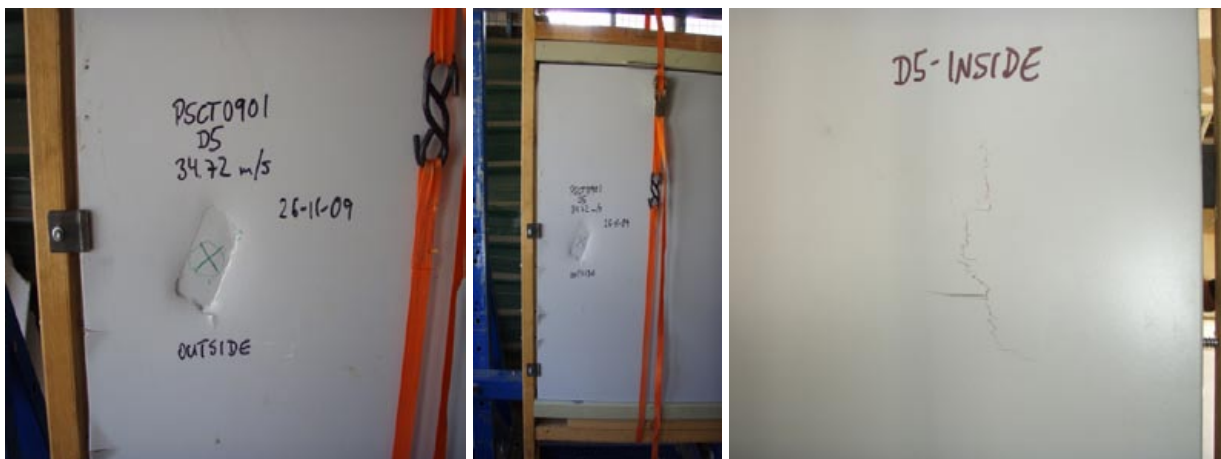
Figure 2: Door damage after Trial SS2

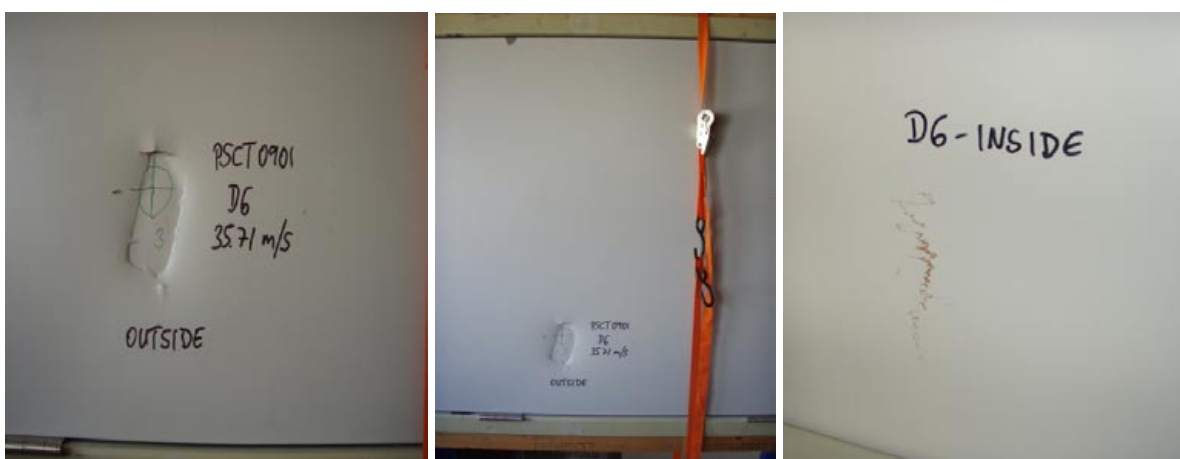
Figure 3: Door damage after Trial SS3

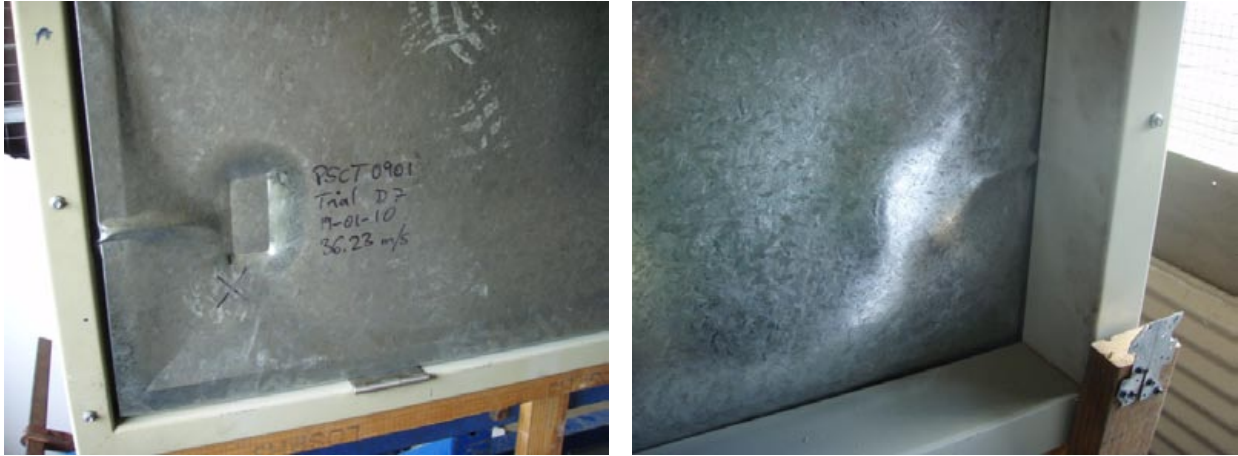
Figure 4: Door damage after Trial SU1

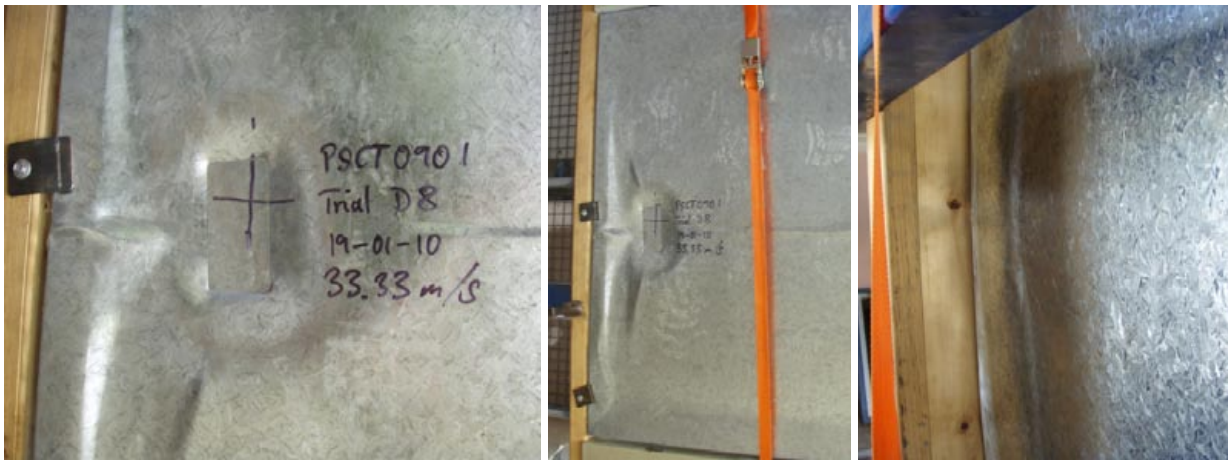
Figure 5: Door damage after Trial SU2

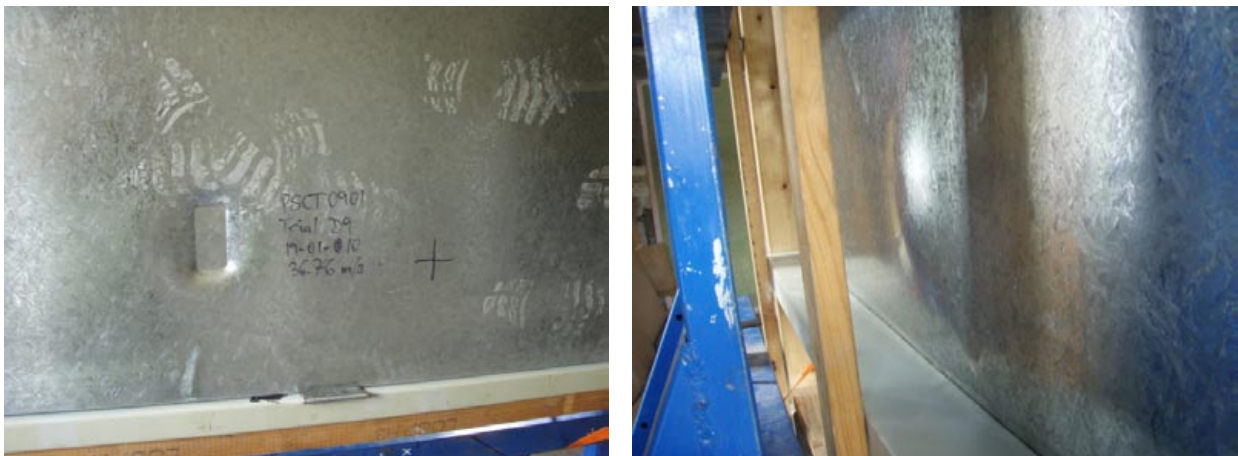
Figure 6: Door damage after Trial SU3
