**REPORT NO. TS776**

# Simulated Wind Driven Debris Impact Testing of Corrugated Roof Cladding

3 September 2010

Cyclone Testing Station  
School of Engineering and Physical Sciences  
James Cook University

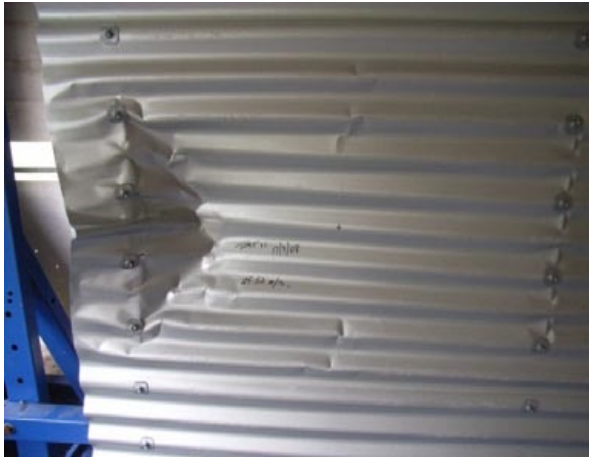
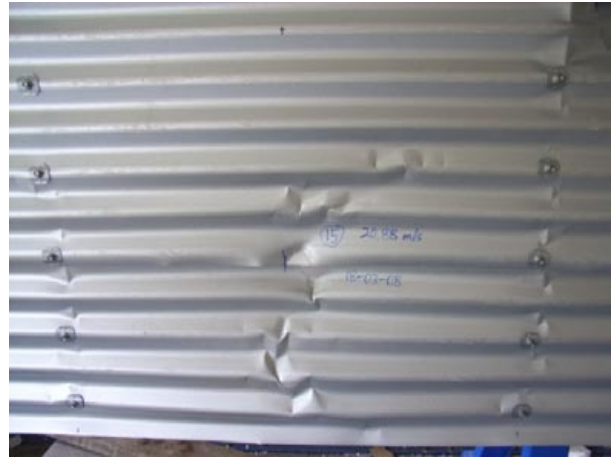
**Figure 5:** Cladding damage after Trials C7 (left) and C8 (right)

Trial No.	Date Tested	Impact Location & Test Load	Impact Velocity (m/s)	Results and Observations
C1	4 Jul 2008	Various (5 impacts), Test Load B	> 34.0	<b>Pass.</b> Small indentations.
C2	12 Mar 2008	Centre of sheet, mid span of end span, Test Load A	9.1	<b>Pass.</b> Deformation across 3 corrugations.
C3	13 Mar 2008	Centre of sheet, mid span of end span, Test Load A	17.2	<b>Pass.</b> Deformation across 8 corrugations.
C4	13 Mar 2008	Centre of sheet, mid span of end span, Test Load A	25.9	<b>Pass.</b> Deformation across entire sheet width. One screw hole on end support elongated.
C5	17 Mar 2008	Side lap, mid span of end span, Test Load A	26.2	<b>Pass.</b> Deformation across 7 corrugations. Small tear (~50 mm) along internal support.
C6	17 Mar 2008	Centre of sheet, mid span of internal span, Test Load A	26.0	<b>Pass.</b> Deformation across 10 corrugations.
C7	17 Mar 2008	Centre of sheet, next to end support in end span, Test Load A	25.5	<b>Pass.</b> Deformation across 9 corrugations. 4 screw holes on end support elongated up to ~30 mm.

C8	17 Mar 2008	Side lap, mid span of internal span, Test Load A	20.9	<b>Pass.</b> Deformation across 7 corrugations.
C9	17 Mar 2008	Centre of sheet, next to internal support in end span, Test Load A	21.3	<b>Pass.</b> Deformation across 8 corrugations. Crack ~50 mm at corner of missile impact location.

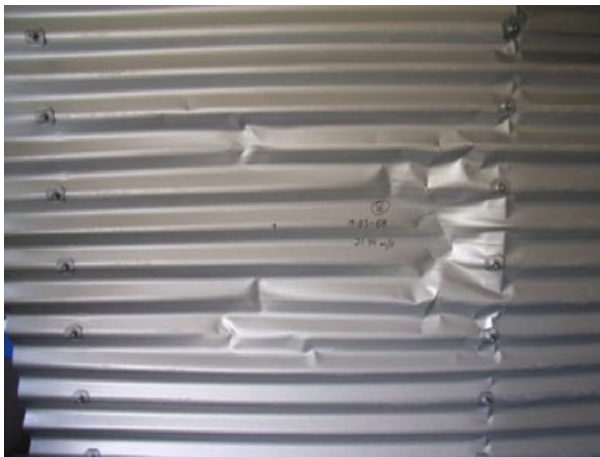
**Figure 6:** Cladding damage after Trial C9
